**PRELIMINARY SITE ASSESSMENT
BAYONNE BARREL AND DRUM COMPANY
NEWARK, NEW JERSEY
AUGUST 1984
TDD #2-8407-25**

PRELIMINARY SITE ASSESSMENT
BAYONNE BARREL AND DRUM COMPANY
NEWARK, NEW JERSEY

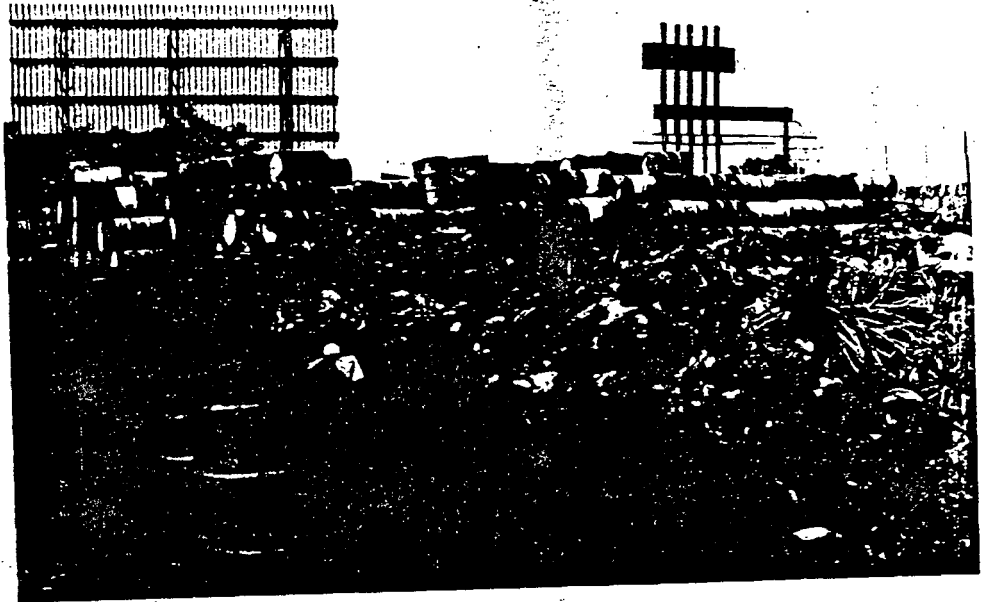
There is a pile of waste ash on the west side of the drum area. It is approximately 110 feet long, 50 feet wide, and 4 feet high, which corresponds to about 1,000 tons of material (calculated as 22,000 cubic feet times 62.43 pounds per cubic foot times an arbitrary density of 1.45). The waste is neither covered on top nor lined underneath. The waste appears black and oily. There was a pool of standing water on the pile. Black mud oozed from the side. OVA readings were 10 ppm over this ooze. An area of soil about 4 feet wide by 60 feet long located at the northwest corner of the open head building looked like it had been dug and refilled.

7. Ash pile with drive-in
sign in background

During the exit conference, Dave Rogers asked Frank Langella whether he could cover the waste pile with plastic sheet. Mr. Langella indicated that he has sufficient sheet in his possession and that he can do so.

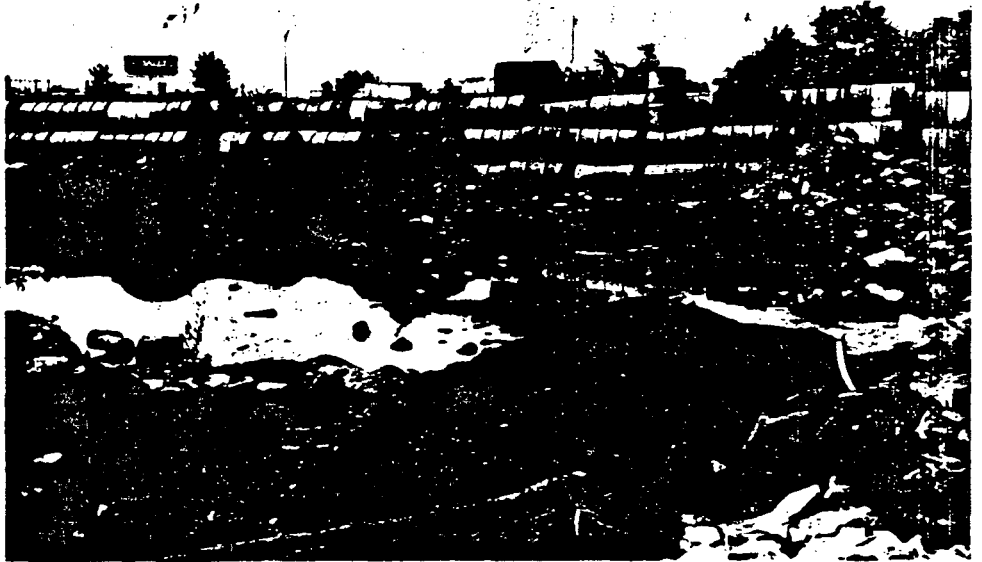
9. Pool of water on top of the ash pile. Note lack of protective cover.

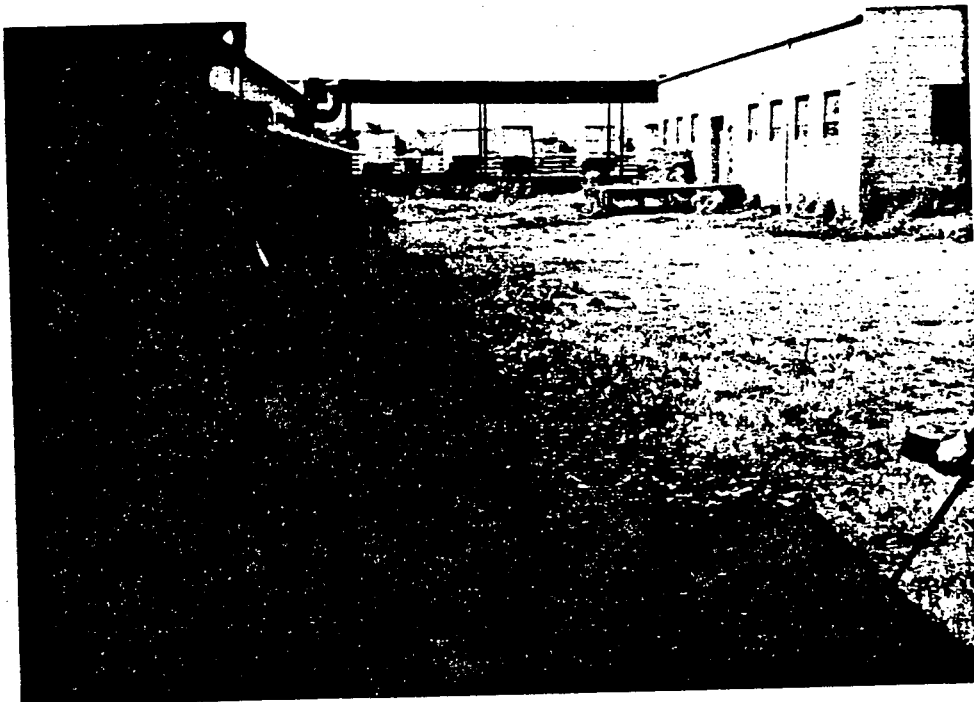
11. Disturbed earth near the northwest
corner of the open head building.
